TECHNICAL REPORT REMR-CO-3

CASE HISTORIES OF CORPS BREAKWATER
AND JETTY STRUCTURES

Report 5

NORTH ATLANTIC DIVISION

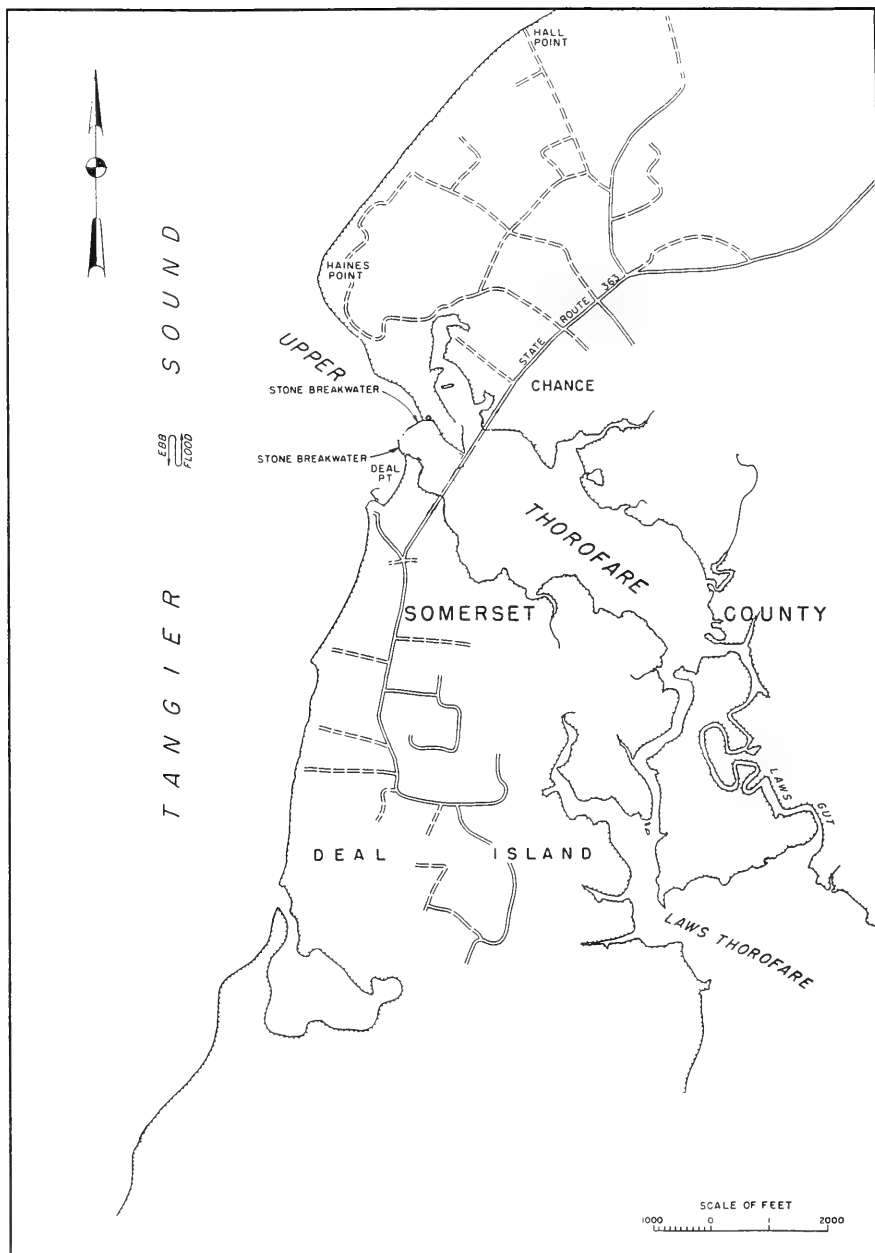
Figure 60. Upper Thorofare, Maryland

<u>Date(s)</u>	<u>Construction and Rehabilitation History</u>
1934	Two stone breakwaters were constructed with 3,650 tons of stone at an estimated cost of \$9,000. The north breakwater was 410 ft long. The south breakwater was 310 ft long. The seaward ends were 180 ft apart (Figure 60). Crest elevations were +7.0 ft mlw, except the landward 142 ft of the south breakwater which was from +5.0 to +6.5 mlw. Crown width was 4.0 ft, and side slopes were 1:1.
1966	Sand had accumulated around one-half to two-thirds of the landward end of the north breakwater. The south breakwater had an average subsidence of 2.0 ft and was repaired to raise the elevation to +7.0 ft mlw. Crown width was 4.0 ft, and side slopes were 1V:1.5H.
1981	A survey indicated the south breakwater was in excellent condition, although the midsection appeared to have subsided 1.0 ft. The north breakwater was almost completely surrounded by sand, and future shoaling of the channel was foreseen. The north breakwater appeared to have subsided 1.0 ft from the original design elevation.

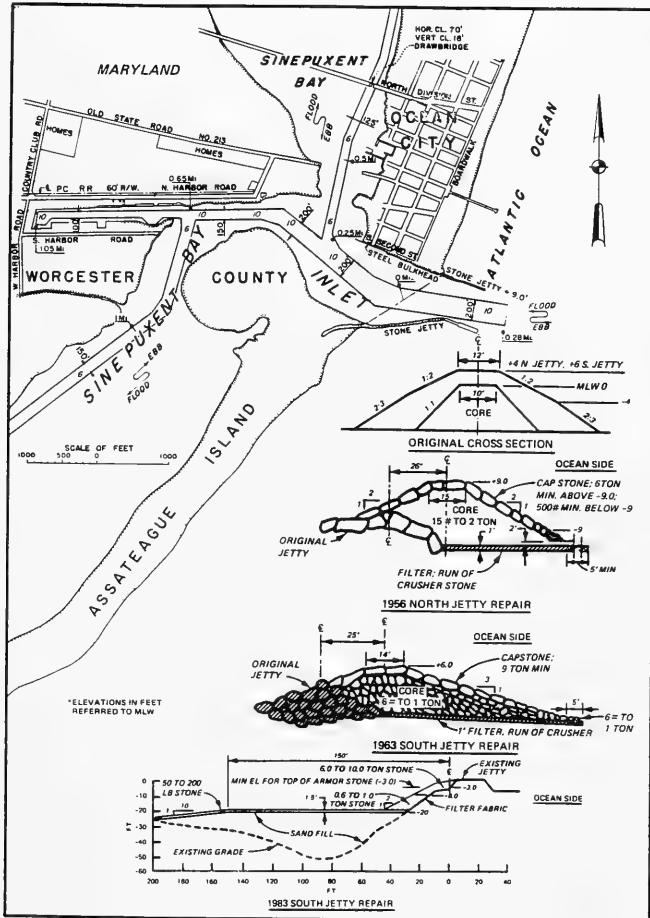
Figure 62. Ocean City Inlet, Maryland

Date(s)	Construction and Rehabilitation History
1934	A 1,100-ft-long jetty was constructed on the north side of a newly formed inlet at Ocean City (Figure 62). Crest elevation was +4.0 mlw, crown width was 12.0 ft, and side slopes were 1V:2H from the crest to -4.0 mlw and 1V:1.5H from -4.0 mlw to the bottom.
1935	Construction was completed on a jetty on the south side of the inlet. Crest elevation was +6.0 ft mlw, and crown width was 12.0 ft. The landward 750 ft of the jetty was 1,100 ft south of the north jetty. The south jetty angled north 1,100 ft to a point 600 ft from the north jetty. The final 530 ft of the south jetty was parallel to that of the north jetty. The crest elevation decreased from +6.0 ft mlw to the apron elevation beginning 170 ft seaward of this final section. The apron extended 200 ft farther seaward. The total length of the jetty was 2,380 ft, including the apron. A total of 39,500 tons of stone was used for core; 17,300 tons were used for capstone on the south jetty.

1937	Sand on the north side of the north jetty had reached the top of the jetty and was depositing in the inlet. A concrete superstructure was built to raise the jetty elevation. The first 100 ft from the boardwalk was raised to +12.0 ft mlw, the next 254 ft was raised to +9.0 ft, and the next 170 ft was raised to +7.0 ft mlw.
1956	Repairs were made on the seaward 750 ft of the north jetty because of slope failures on the channel side from toe scour. The existing concrete cap was repaired and raised to +9.0 ft. Armor stone was placed on the seaward 575 ft. The armor stone section was placed 26 ft north of the center line to use existing stone as toe protection and to minimize the stone required. The landward end of the south jetty was repaired to maintain integrity with the shoreline.
1963	Approximately 720 ft of the south jetty was rehabilitated due to slope failures caused by a scour hole that had an elevation of -37 ft mlw. Armor stone was placed 25 ft seaward of the center line for the same reasons stated above in positioning the north jetty. The landward end of the south jetty was again repaired to maintain integrity with the shoreline.

1984	The seaward 1,100 ft of the south jetty was rehabilitated due to slope failures. The section repaired in 1963 had deteriorated. The scour hole had a maximum depth of -54 ft mlw. Repairs consisted of filling the scour hole with dredged material to -20 ft mlw, covering the hole with 18 in. of blanket stone, and placing stone berm quarry run and armor stone along the toe on the channel side of the

Date(s)	Construction and Rehabilitation History
1984 (Cont.)	existing jetty. The landward end of the south jetty was sand tight-ened to prevent material from passing through the jetty and shoaling into the channel. Three rubble mound breakwaters were constructed landward of the jetty to prevent expected erosion from occurring as a result of sand tightening.
1986	No further repair or maintenance information has been found.
